Rebuilding the rudder on a 419

by Mike Pearce

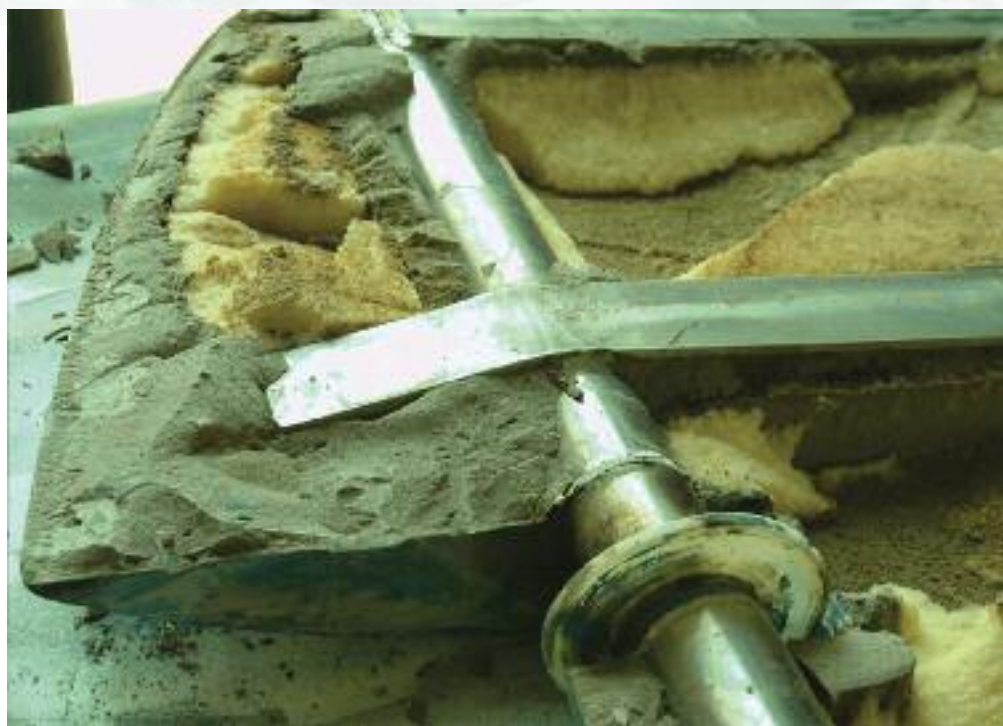
Inside, the stainless steel web was in good condition and the small amount of epoxy round the web was solid. However the foam filler that occupied the majority of the internal volume was totally waterlogged. Handfuls could be pulled out and water squeezed from it like a sponge.

Internal structure before chopping out

I spent an afternoon with a hammer, cold chisel and various scraper tools removing all the foam and original epoxy so we ended up with just the web and the two fibreglass outer halves of the rudder. The guys from the yard then filled the rudder with new epoxy and bead filler, building it up in layers. This was quite a skilled operation as the next layer had to be added at

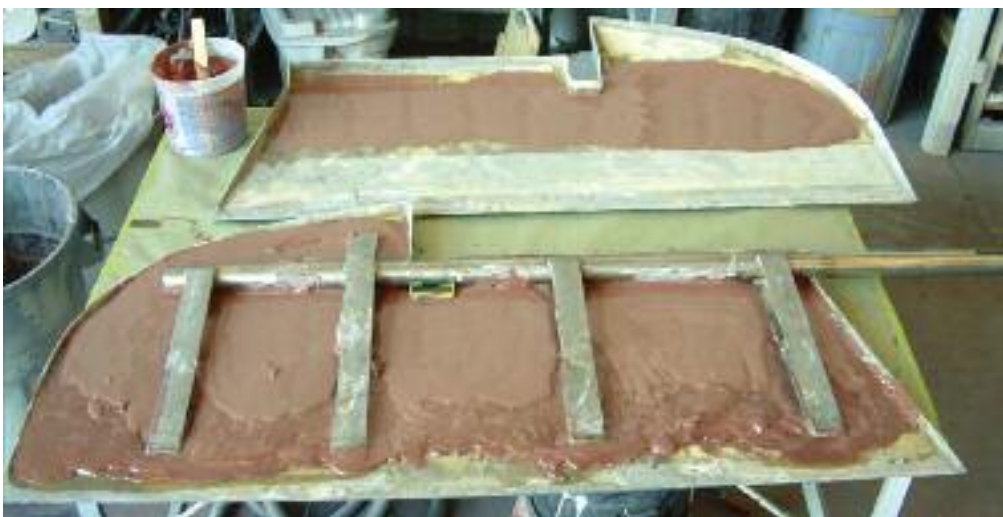
The two halves cleaned out and starting the rebuild

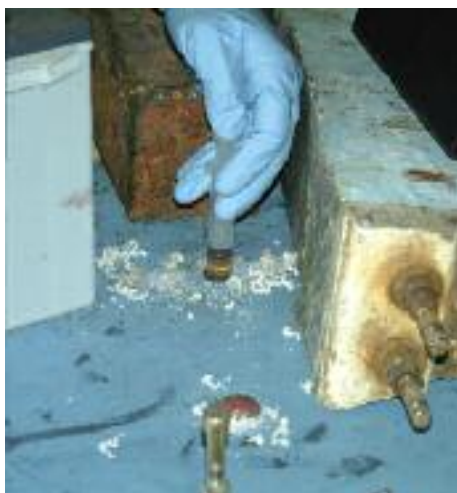
Filling a void with epoxy coming out of the exit hole

Once dry the shell was tap-tested to find any voids. Two small holes were drilled at either end of each void and using a syringe epoxy was injected in one hole until it appeared in the exit hole making sure the void was completely filled.

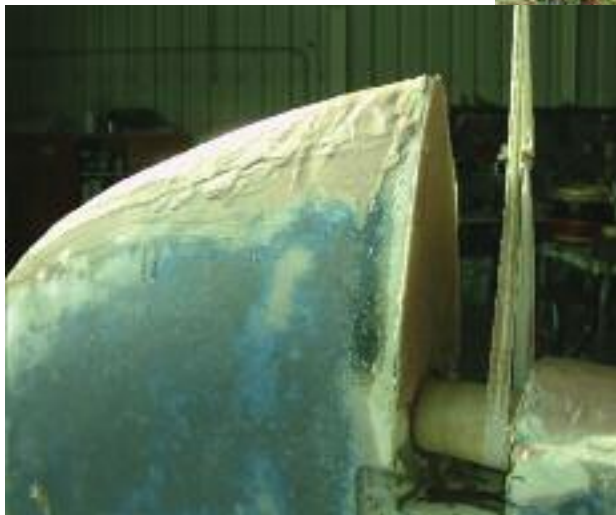
Edges taped and filled

Once the rudder was full and given time to dry, fibre-glass reinforcement tape was applied to the join between the two halves of the shell, then filled and smoothed to get a good clean curve.

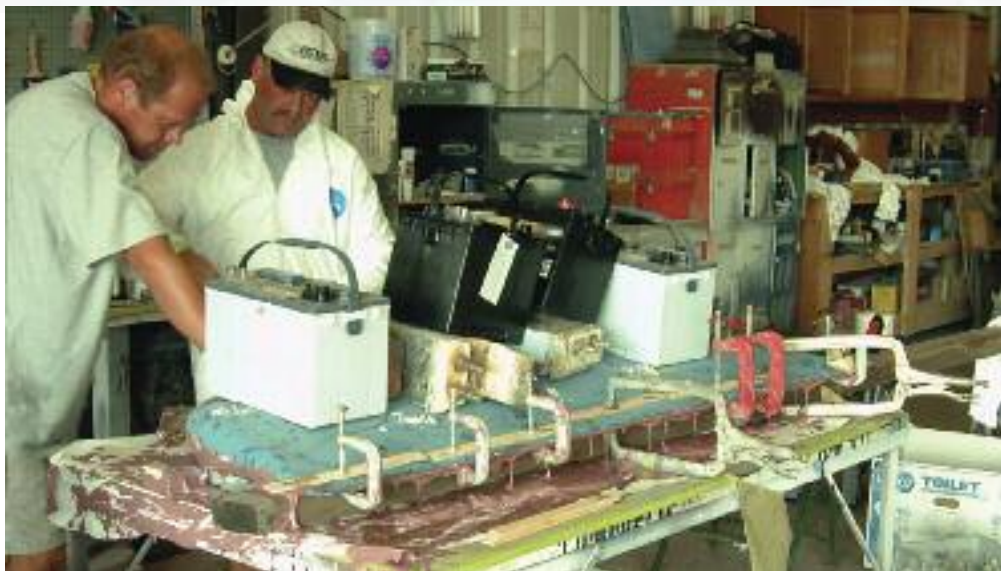
Joined, weighted down and clamped

This was weighted down with batteries and large lumps of lead removed from a power-boat bilge to make a good seal.

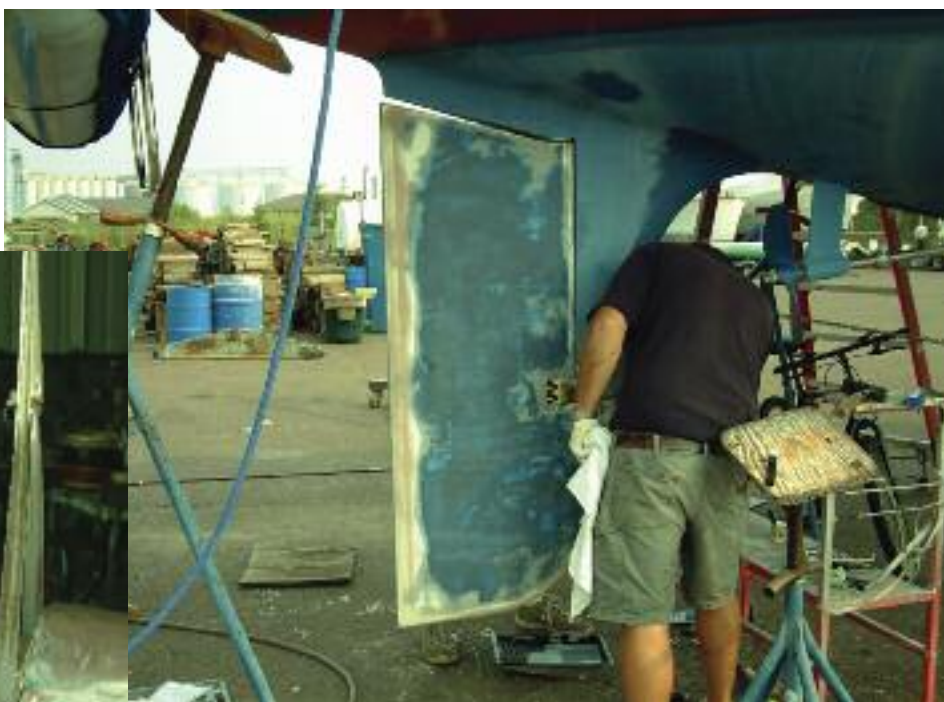
Edges smoothed and rudder refitted

Refitting was the reverse of getting it off the boat with the main problem being weight. A jack and four large men solved the problem.
