Split rudder repair 2009/2010

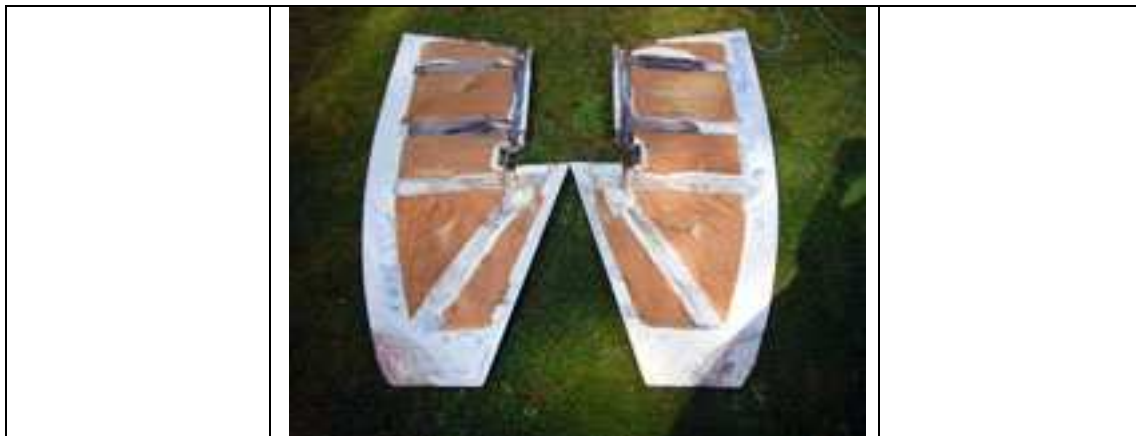
With some difficulty, I tried to turn against the wind in the confined space, but as we came astern the rudder hit the canal bank and some bits of foam appeared on the surface. I presumed that the tip of the rudder had been broken off, but steering seemed fine so we continued on our way. After descending a few locks we set off along the next reach, but had only motored a short distance when I felt a slight bump and, looking aft, saw half my rudder floating away! Luckily the wind was on the nose and neatly swung the boat round as I cut the engine revs and we drifted back to a nearby pontoon berth. The half rudder, which had split vertically, was retrieved from the canal side bushes by inflatable dinghy. Next day an obliging crew of a large racing yacht all stood on the foredeck as I drilled a hole in the top corner of the remaining half rudder and attached a rope as a precaution. We then took a tow from a passing yacht, just in case the rudder came completely to bits and we lost steerage, however we made it to the canal exit basin without a problem. The weather was still bad so we went home by car and returned a few days later on a friend's yacht to retrieve Saorsa for the thirty mile tow home. The rudder behaved perfectly until we were rounding Ardlamont Point in a bit of a chop and I realised we were towing the remainder of the rudder. It is surprising just how much directional control still exists with only the bare skeleton of the rudder! *Close inspection of the two rudder halves showed that the rudder had suffered slight damage to the lower trailing edge some time in the past and that some water penetration was evident.*

We dried out in our local harbour for inspection and, on finding no damage to the steelwork, elected to go for a lift out at our local boatyard and a temporary repair to last the season.

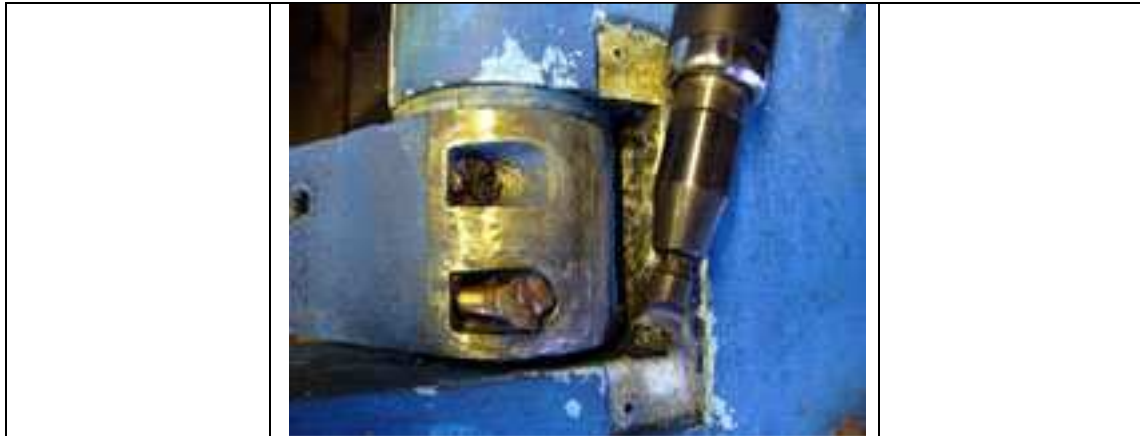
On lift out at the end of the season, the rudder was removed by first unbolting the steering mechanism. At this stage I discovered that the “earthing” cable which should have been attached to the rudder stock was broken. The rivet heads on the lower rudder bearing shoe were drilled off and the rivets knocked out. The heads of the slotted screws holding the lower bearing were in a poor condition, possibly electrolysis due to the rudder having no direct connection to the sacrificial anode.

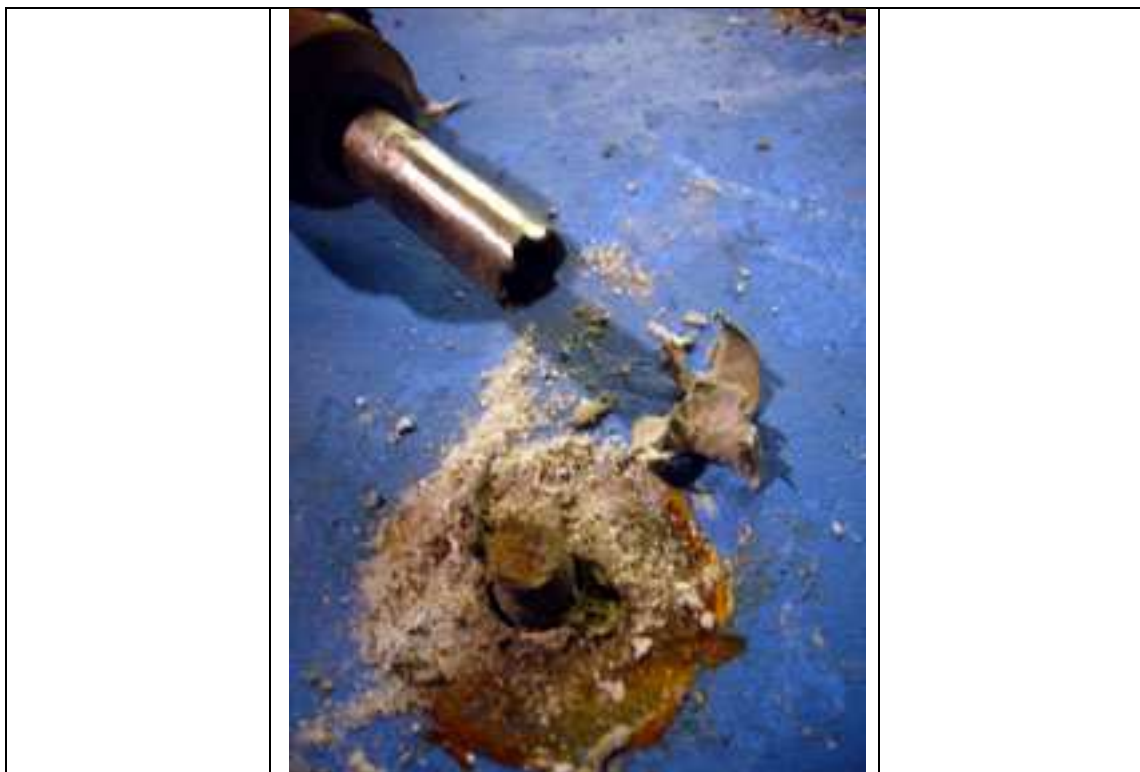
An impact screwdriver was needed to loosen these screws but the heads of two had to be drilled out. All the screw threads were in perfect condition. This posed an additional problem as it proved impossible to source replacements - the screw threads were found to be the old British Standard Whitworth and no longer available. However a length silicone bronze rod was purchased and a friend who had access to a lathe kindly machined new ones. A drill, made from a piece of steel tube,

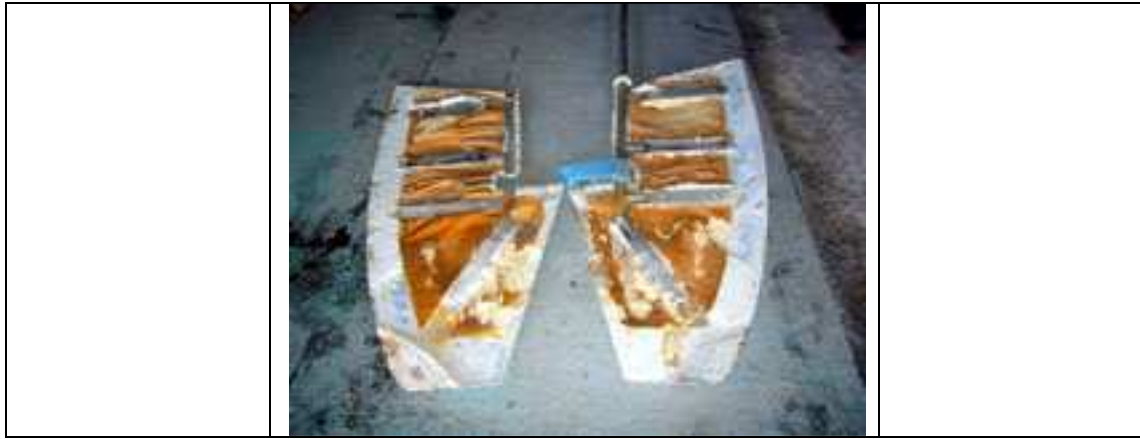
had to be used to release the temporary bolts holding the two halves of the rudder together, before they could be removed and the rudder split, with great difficulty, using an old paint scraper and a hammer. The polyurethane glue had done a superb job and there was little evidence of water ingress. (P1030321)
