Rudder Overhaul

by Chris Haire

Exhaust/cooling water injection elbow

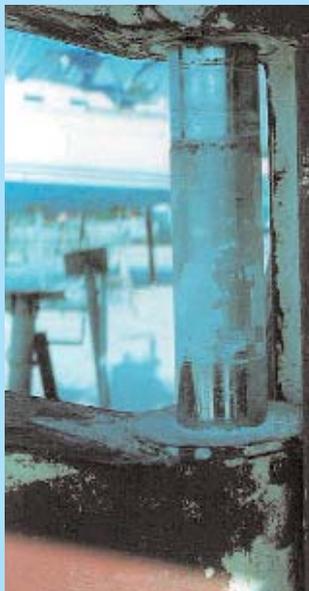
Above left: Lowered rudder shafts showing oxide deposits

taking the rudder out. The cause of the corrosion to the quadrant was the result of the contact of 2 dissimilar metals lubricated by salt water from the defective seals. Contact had occurred due to the rudder shaft dropping 5mm when a nylon spacer located in the heel fitting disintegrated. Although the rudder assembly was wired to the anodes, the aluminium of the quadrant was more vulnerable than the zinc on the anodes.

The rudder was manhandled into the back of an estate car and taken to the machine shop so that the bronze heel fitting could be separated and the deposits polished off the shaft. It was necessary to dismantle the heel bearing as it was the only way to replace the nylon spacers – these were split so that they could be folded around the exposed lower section of the rudder shaft which was otherwise encapsulated within the fibreglass structure of the rudder. The slotted head bolts, once removed, were too badly damaged to be reused. The

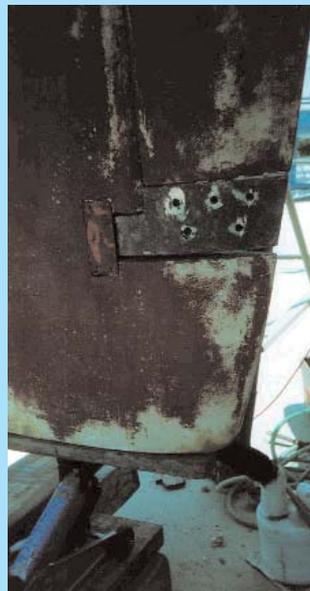
Above right: Rudder held in position prior to fitting new rivets

With the rudder back in position, there just remained the refixing of the heel to the skeg using 12mm copper rods with the ends beaten over – a job requiring two persons and extra heavy club hammers. To assist in burring over the rod ends, a strong punch was held at the end of the rod and then hammered. Finally, the quadrant was refixed and the steering cables reattached and greased. The steering is now as it was when I first bought the boat – as light as a feather.

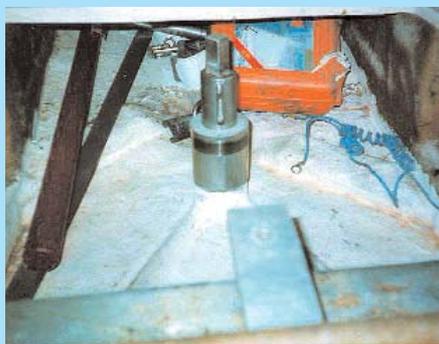
Extended rudder tube and additional o rings prior to glassing to hull

To forestall a repeat occurrence of O-ring failure the rudder tube within the hull was extended above the waterline to finish just below the underside of the

quadrant. An oversized piece of stainless steel tube containing 2 Delrin bushes each holding an additional O-ring was slid over the rudder shaft – now refitted to the hull. The stainless steel tube was covered in a thin plastic slip-sheet to which glass fibre and resin was applied moulding it to the inside of the hull. The tube is held in place to prevent rotation by self taping screws taken through the fibreglass into the metal. Should the lower O-rings need replacing it should be possible to separate the extension tube from its supporting GRP surround.

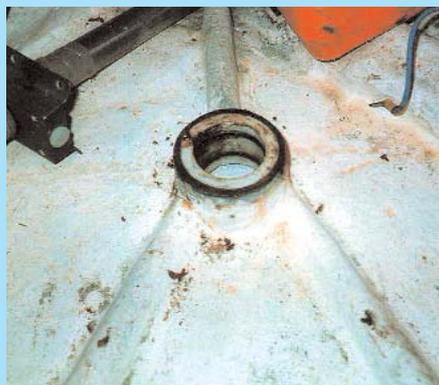
Existing rudder shaft hub with o rings

The cause for the original seepage of water through the top of the rudder tube could be ascribed to the failure of the neoprene O-rings located within a hub bonded to the hull. These had been fitted as a postproduction modification by the manufacturer as a replacement for the original stuffing box, which had been deemed unsatisfactory. To change the O-rings would require dismantling the rudder bearings and

Before offering back the rudder for re-assembly, the O-rings in the hub were replaced.

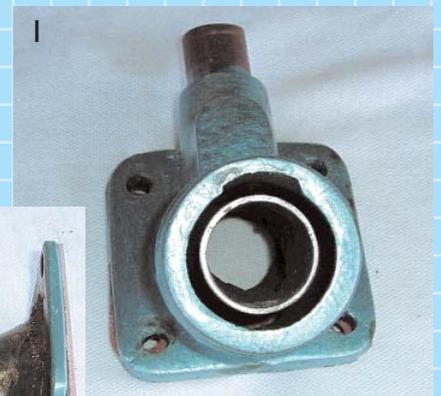
1. Shows correct clearance between exhaust pipe and water injection elbow
2. Exhaust pie (right part) and water outlet pipe
3. Corrosion in exhaust outlet
4. Heat exchanger (top) and exhaust outlet

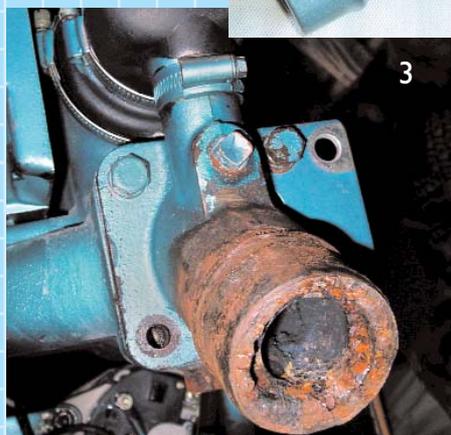
However, to get at the water pump satisfactorily I needed to remove the engine exhaust pipe. Having got the old exhaust hose disconnected I happened to inspect the exhaust elbow where the cooling water is injected into the engine exhaust. From the photograph (pic 3) it is evident that there was very little clearance remaining between the water injection pipe and the exhaust pipe itself.

Removal of the exhaust elbow was not complicated, but on inspecting the amounts of very hard deposits in the exhaust pipe I decided that a replacement unit was better

than trying to clean up the old one. All the parts were obtained from Thornycroft Engines who provided an excellent service, even supplying new bolts and gaskets, in addition to the elbow and water connection parts and of course the rubber bellows.
